Former NAS Brunswick

Restoration Advisory Board Meeting

20 November 2019

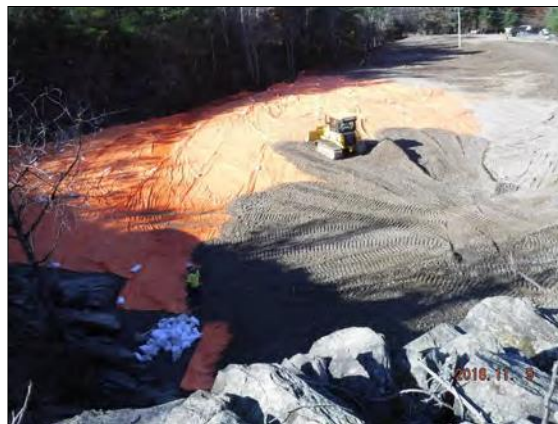
Quarry Soil Cover Completion Construction Tasks – Fall 2018

- **Removed aboveground debris**
- **Cleared munitions of concern if present**
 - Berm area
 - Rock wall
 - Perimeter fence area
- **Installed 1-foot-thick (minimum) protective soil cap including:**
 - Re-use of berm area soil
 - Sub-base drainage layer
 - Demarcation geotextile
 - Common fill and topsoil

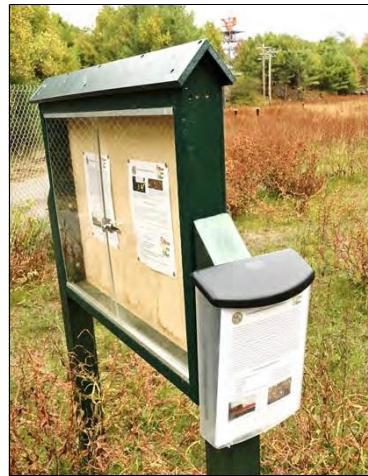
Quarry Soil Cover Completion Restoration Tasks – 2019

- Installed monitoring wells
- Seeded protective cap and disturbed areas
- Installed LUC signs
- Installed kiosk with UXO safety sheets

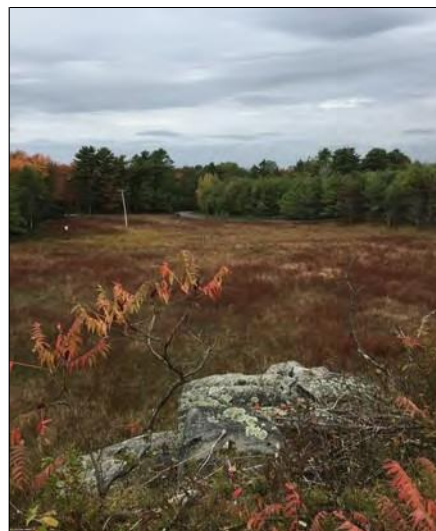
Quarry Soil Cover Completion Tasks

- Submitted Completion Report in October 2019
- Inspections in June and October 2019
- Long-term monitoring to be conducted
- LUCs implemented for protection of the public and environment

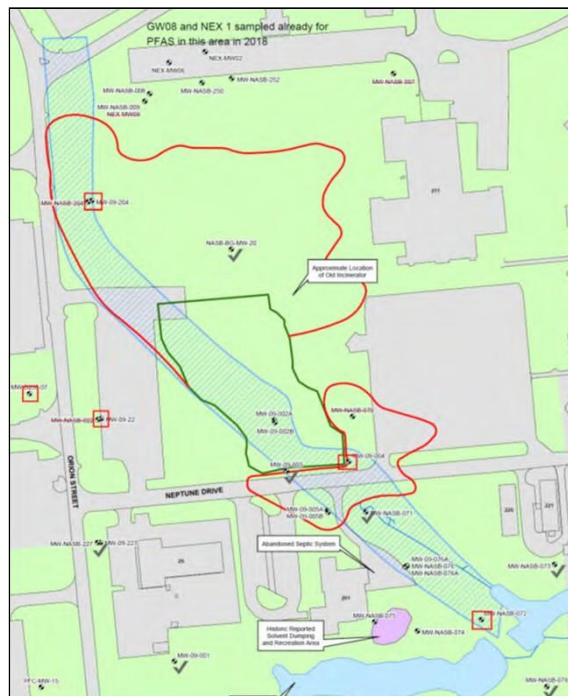
Site 9 Wells Sampled for PFAS

- **Neptune Drive Disposal Site—Former incinerator and ash landfill/dump area located east of/across Orion Street from central portion of the airfield**
- **Investigated to support property transfer for town-planned redevelopment (recreational) north of Neptune Drive**
- **Sampled five wells to build on earlier PFAS sampling in the area**
 - One of five wells (located adjacent to the impoundment ponds) had combined PFOA/PFOS slightly above the LHA
 - Prior sampling results include PFAS exceedances in wells south of Neptune Drive, not in central Site 9 area

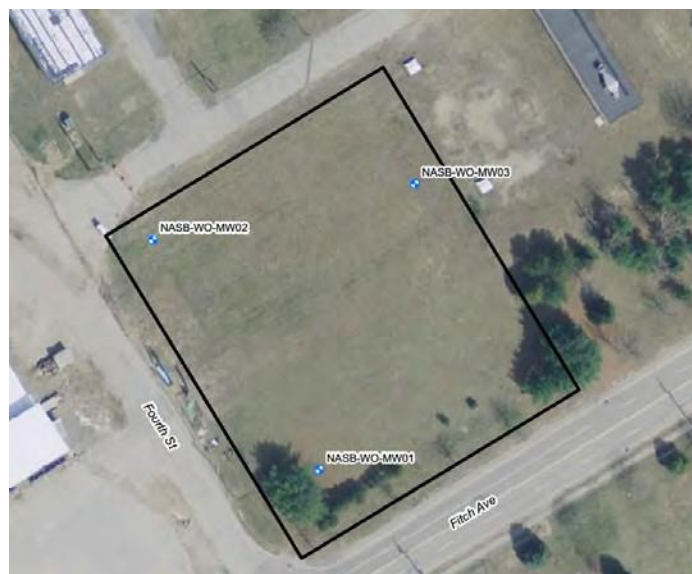
**Wild Oats
Property,
Well
Locations**

- **Planned restaurant located along Fitch Avenue in central area of the former base**
- **Investigated to support planned building construction activities**
- **Installed and sampled three shallow wells for PFAS**
 - All results were well below the LHA (maximum 29 ng/L combined PFOA/PFOS)
 - Nearby Building 223 and Lot 15 parcels were investigated previously for PFAS with no issues identified

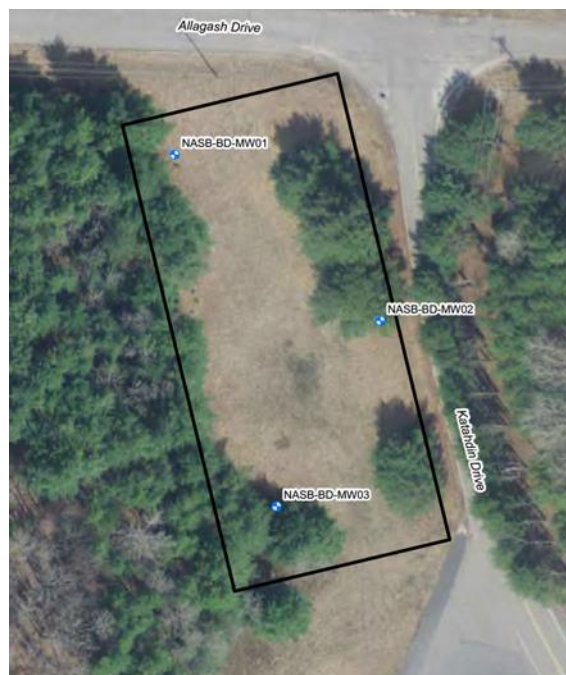
**Blue Dog
Property,
Well
Locations**

- **Planned dog day care facility located in the north-central area of the former base**
- **Investigated to support planned building construction activities**
- **Installed and sampled three shallow wells for PFAS**
 - Two of three results were well below the LHA (maximum 29 ng/L combined PFOA/PFOS)
 - One well slightly exceeded the LHA for PFOA (71.45 ng/L) and combined PFOA/PFOS (83.28 ng/L) but is north of the planned construction area
 - Building 653 (PFAS-impacted) is approximately 500 feet south-southwest of the Blue Dog location

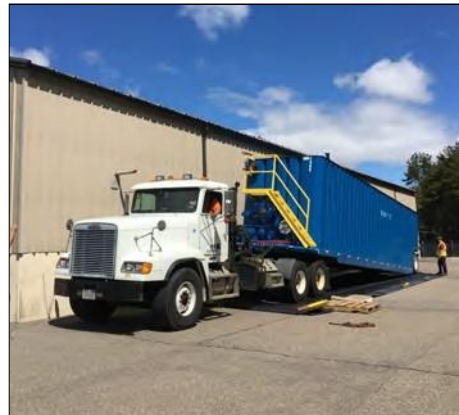
The CDWTS was designed and installed by the Navy to facilitate redevelopment of former Navy properties with PFAS contamination by treating PFAS from construction water generated during redevelopment and construction activities.

Influent Tank Outside Treatment Building

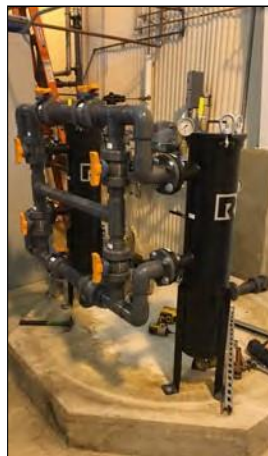
- Influent Tank
- Transfer Pump
- Two Bag Filters
 - 25 to 10-micron bag
- Two GAC Filters
 - 1,000 pounds each
 - Up to 25-gpm flow rate

Bag Filters

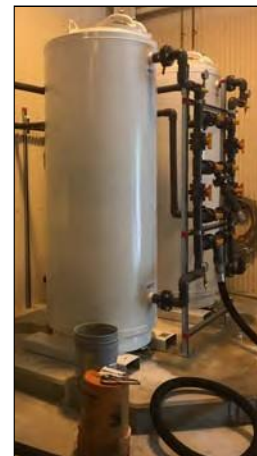
GAC Filters
